## FINAL REPORT

# WHITPAIN TOWNSHIP BASIN RETROFIT PROJECT

September 15, 2010

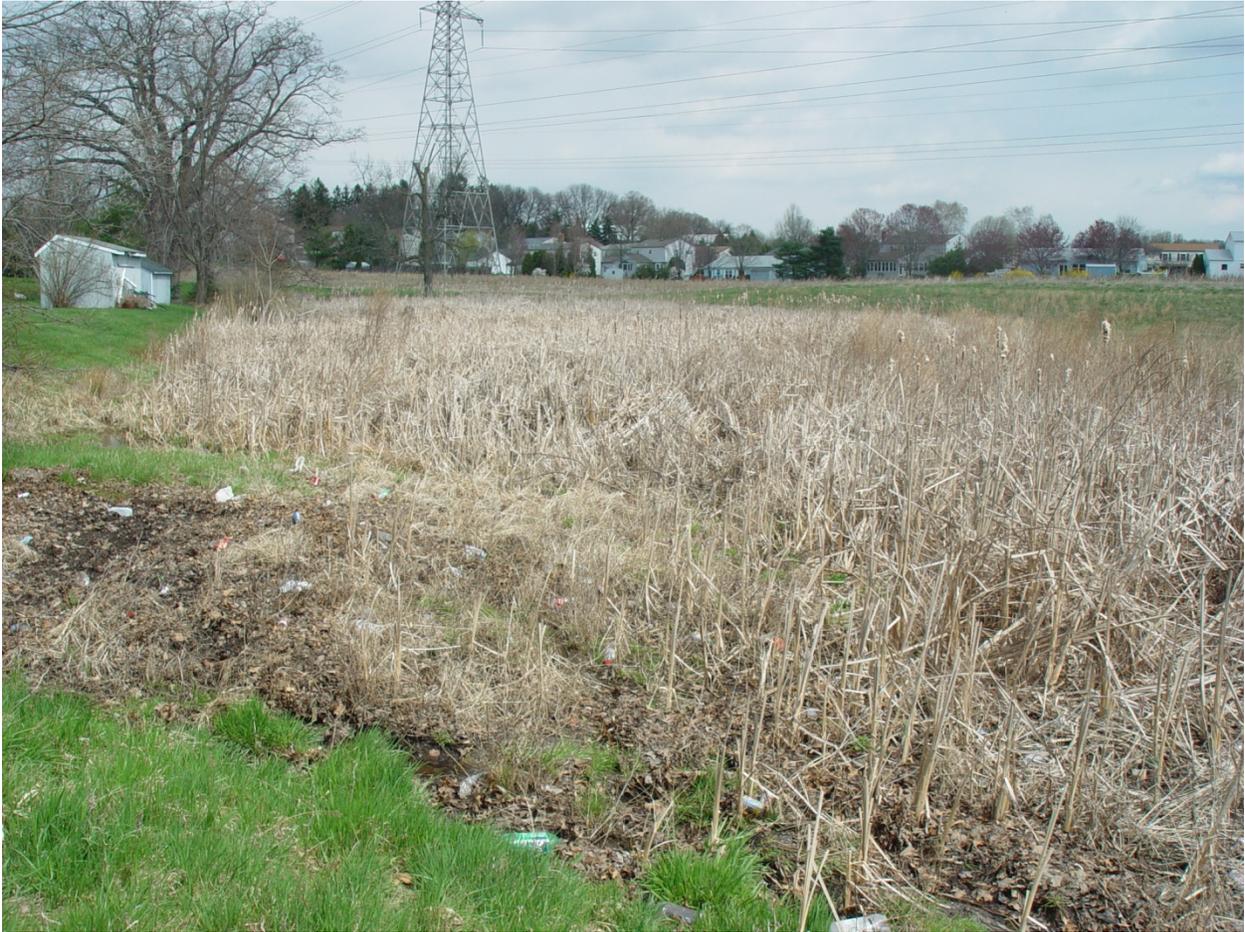
**Prior Condition - Blue Bell Run Basin – North View.**

The basin berm is on the left hand side and top of the picture. The basin bottom has been inundated with invasive plants.

7. The basin has a substantial amount of invasive plant growth that inhibited the growth of native plants. **The project removed all invasive plants within the basin footprint and the entire basin was replanted with meadow and basin grass mixes appropriate for a naturalized basin environment.**

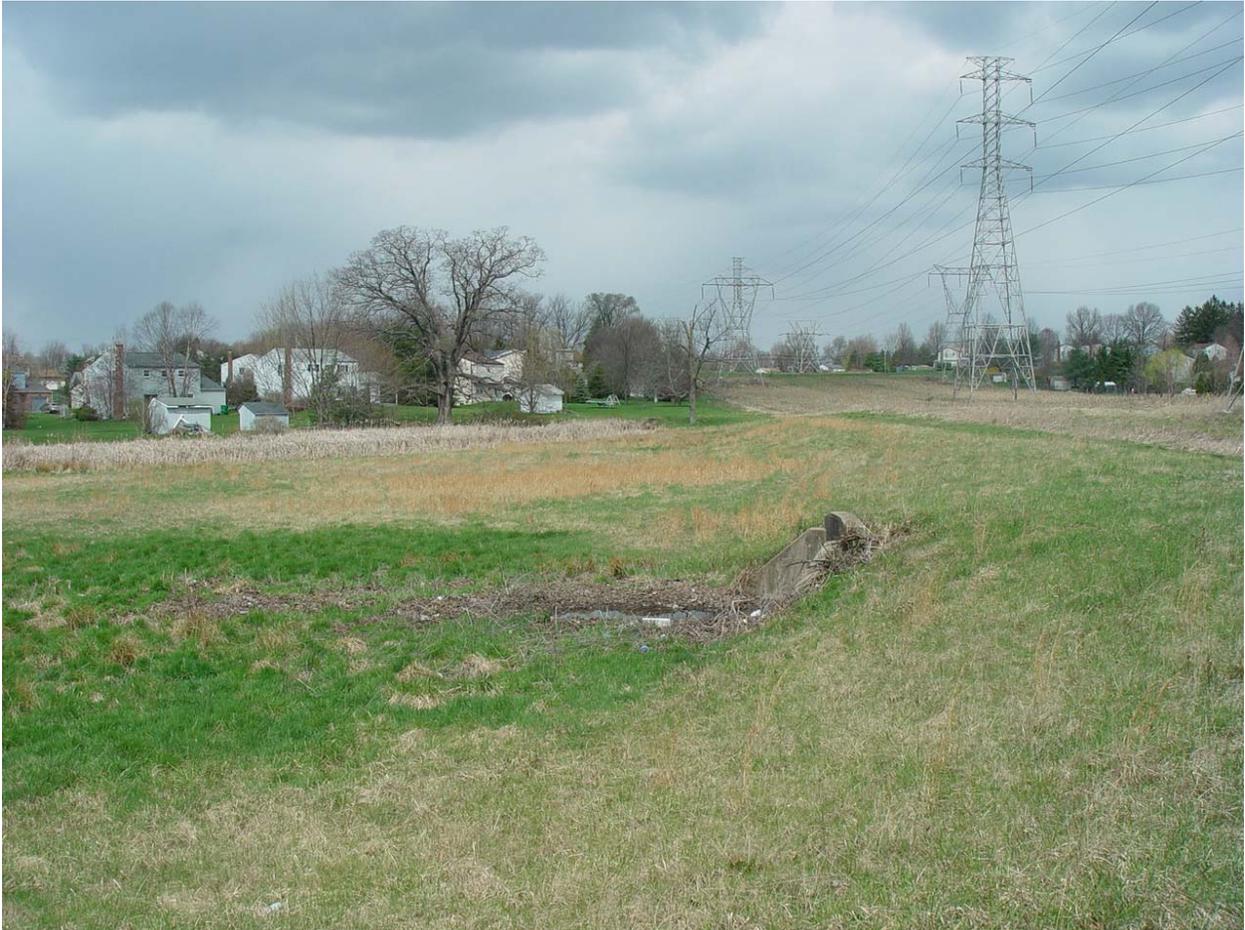
**Prior Condition - Blue Bell Run Basin – West View.**

The basin berm is on the right hand side of the picture. The inlet pipe from the northern half of the drainage area is shown. Extensive erosion and sedimentation can be observed around the pipe. The agricultural use on the PECO easement can be seen on the right hand side of the picture.

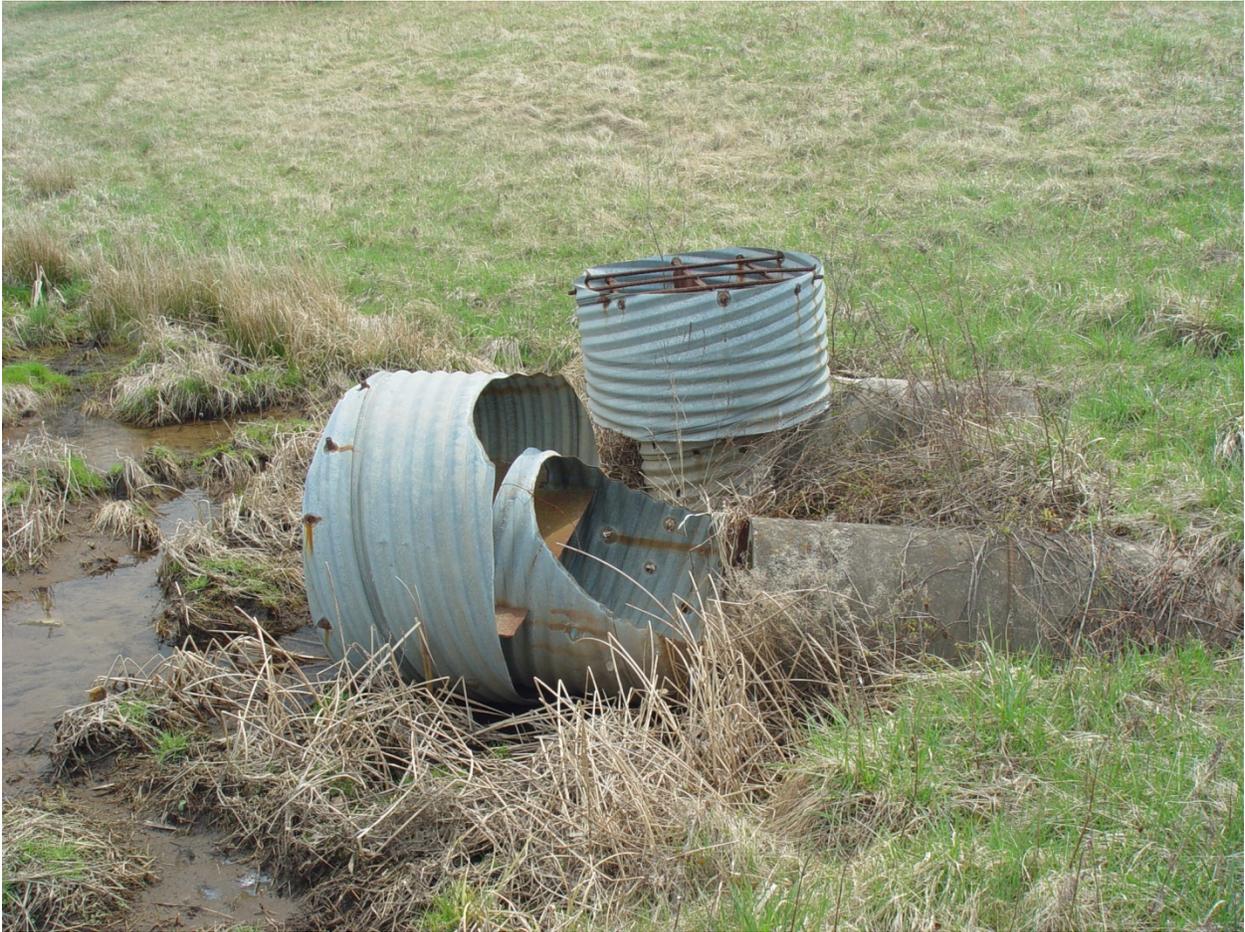
**Prior Condition - Blue Bell Run Basin – Outlet Pipes.**

The CMP temporary riser pipes are in disrepair and they are only partially attached to the basin outlet pipes.

8. The temporary riser pipes (vertical corrugated metal pipes) had never been removed and were in a state of disrepair. In addition, the outlet structure was in need of repair. **The project included the removal of the temporary riser pipes and the repair of the outlet structure.**

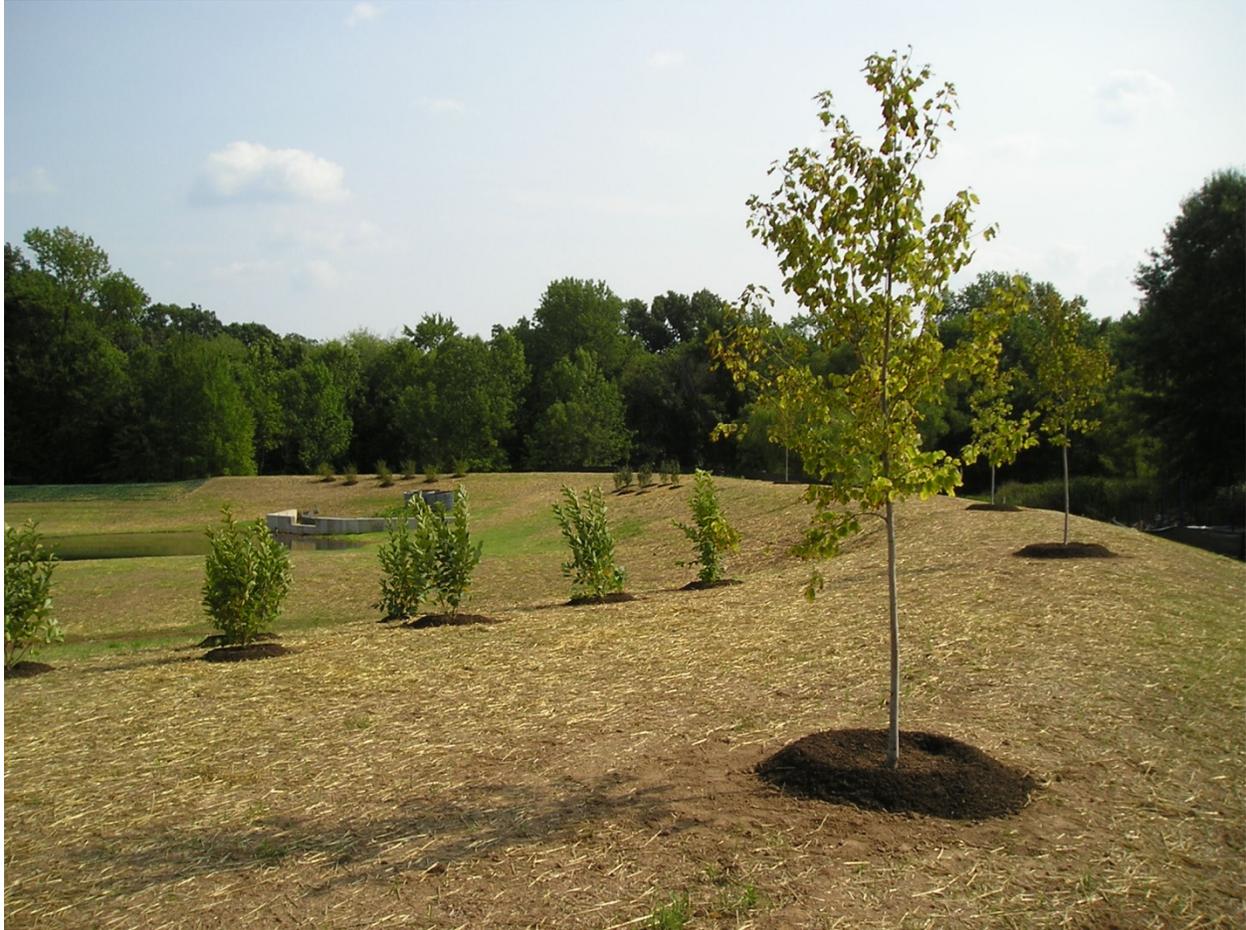
**Project Completion - Blue Bell Run Basin – Southeast View.**

The basin berm is in the foreground. The new basin outlet structure weir wall is at the center left of the picture.

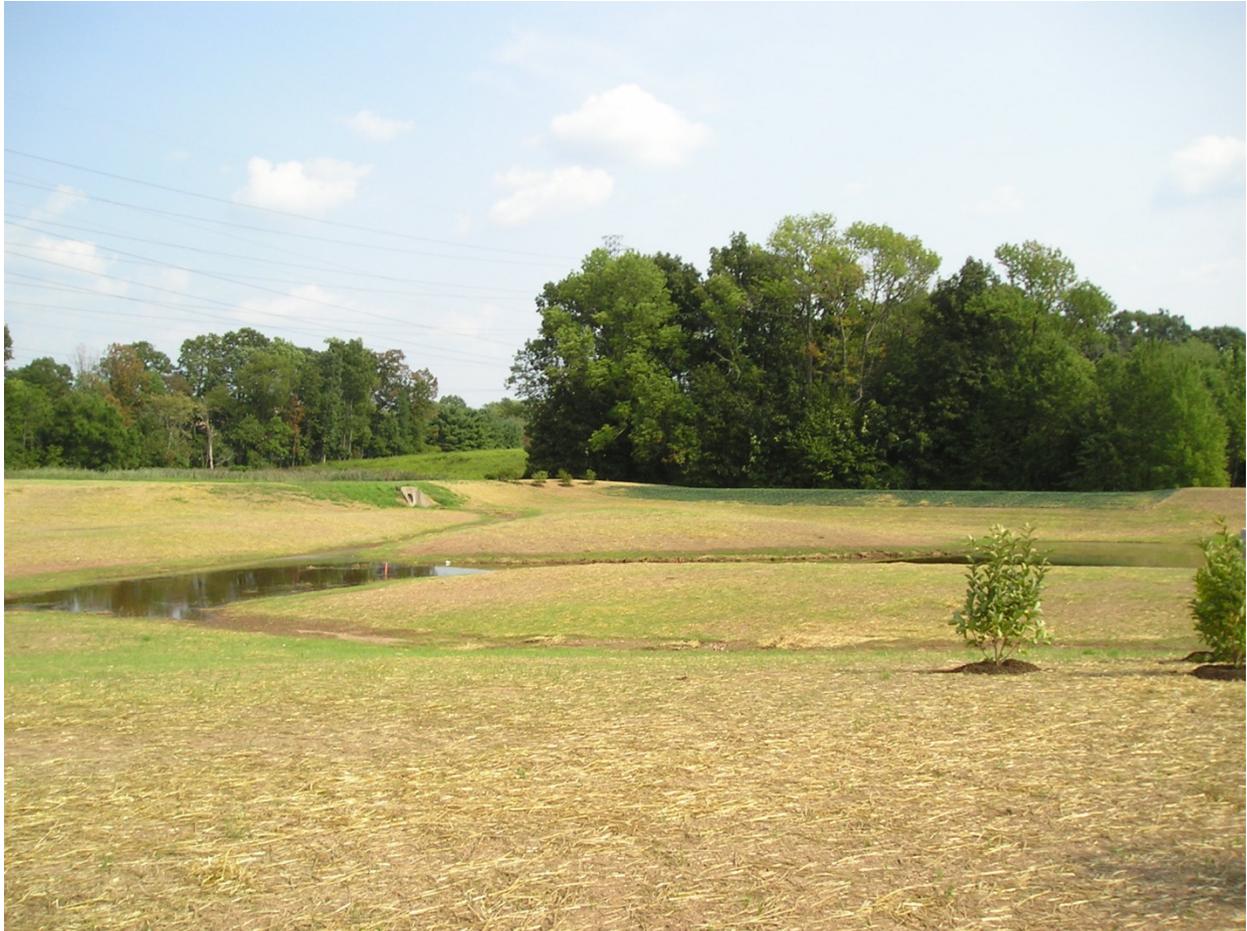
**Project Completion - Blue Bell Run Basin – East View.**

The lengthened flow paths can be seen in this picture. The new emergency spillway is at the right of the picture below the tree line.

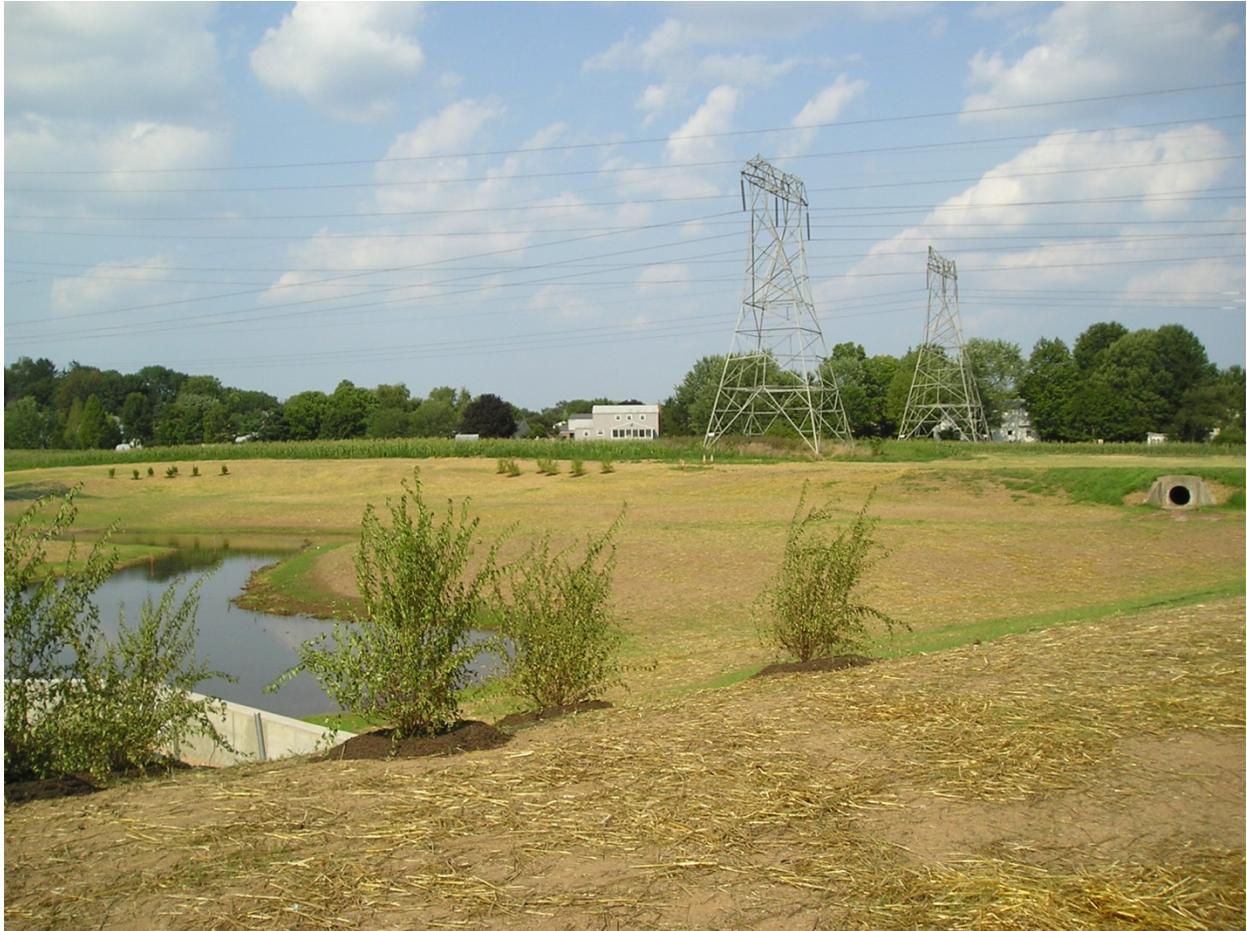
**Project Completion - Blue Bell Run Basin – North View.**

The re-graded basin with the permanent pool of water is shown.

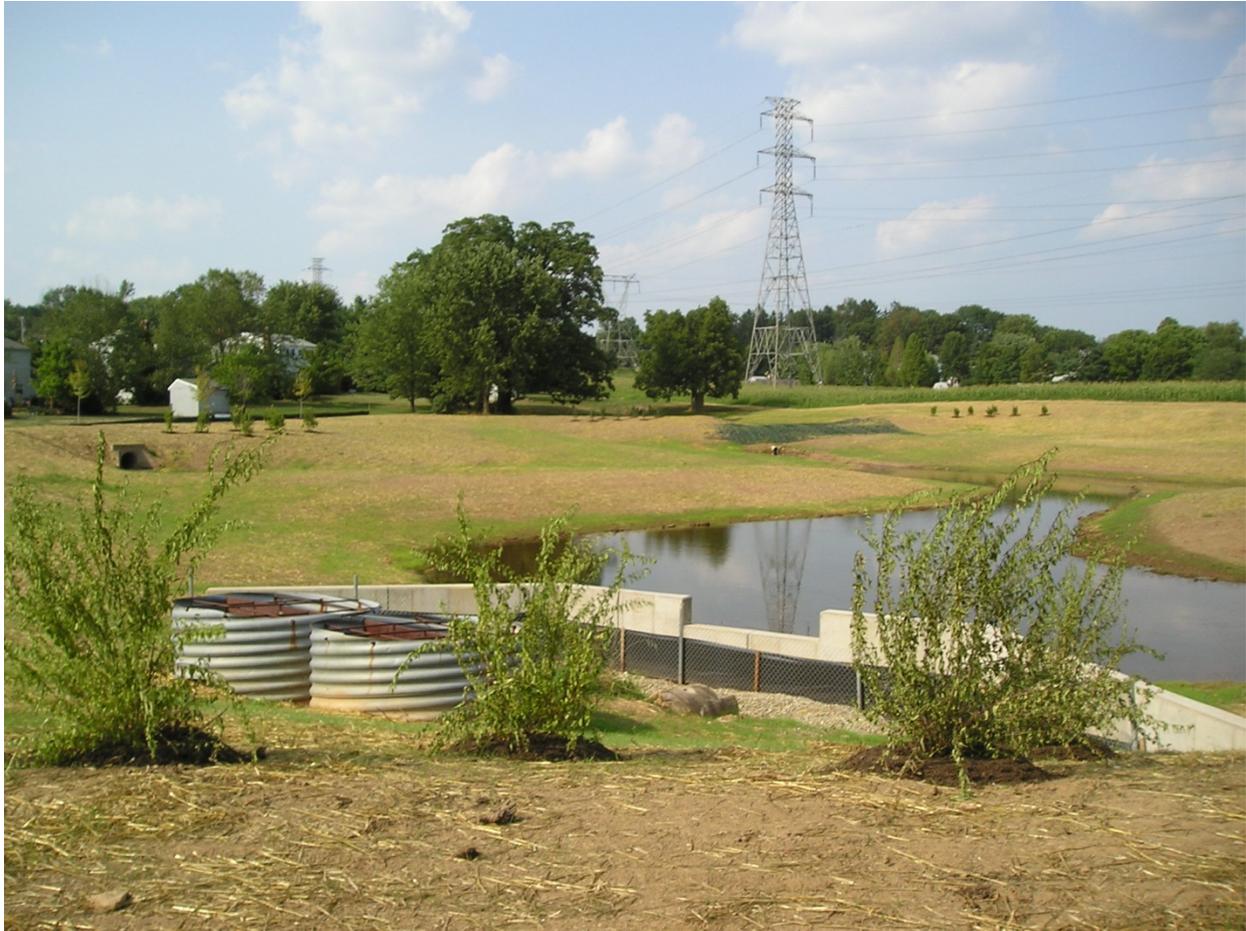
**Project Completion - Blue Bell Run Basin – Northwest View.**

The new outlet structure weir wall & secondary outlet structure are in the foreground.

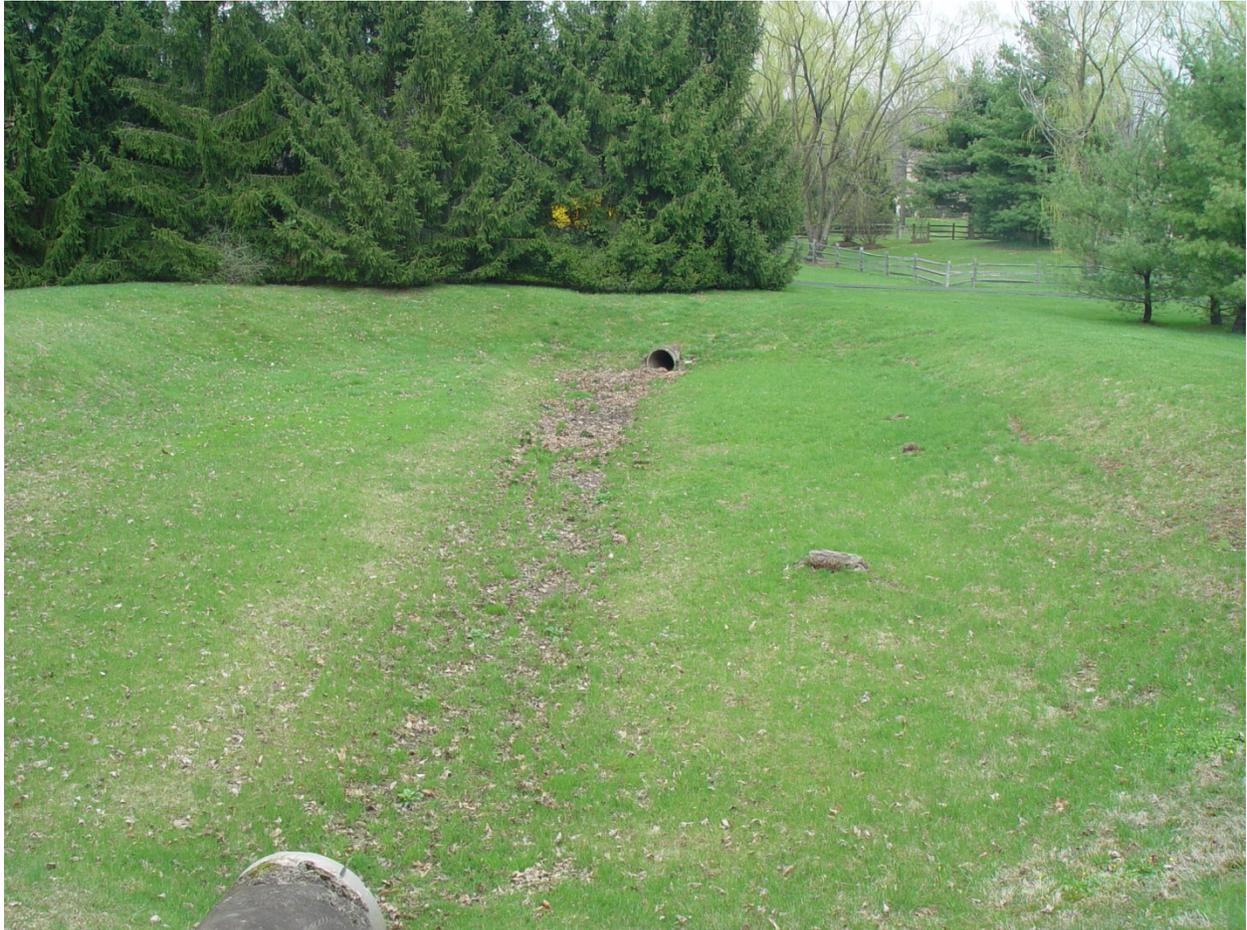
**Prior Condition - Valentine Estates Basin.**

The inlet pipe is at the top of the picture and the outlet pipe is at the bottom of the picture.

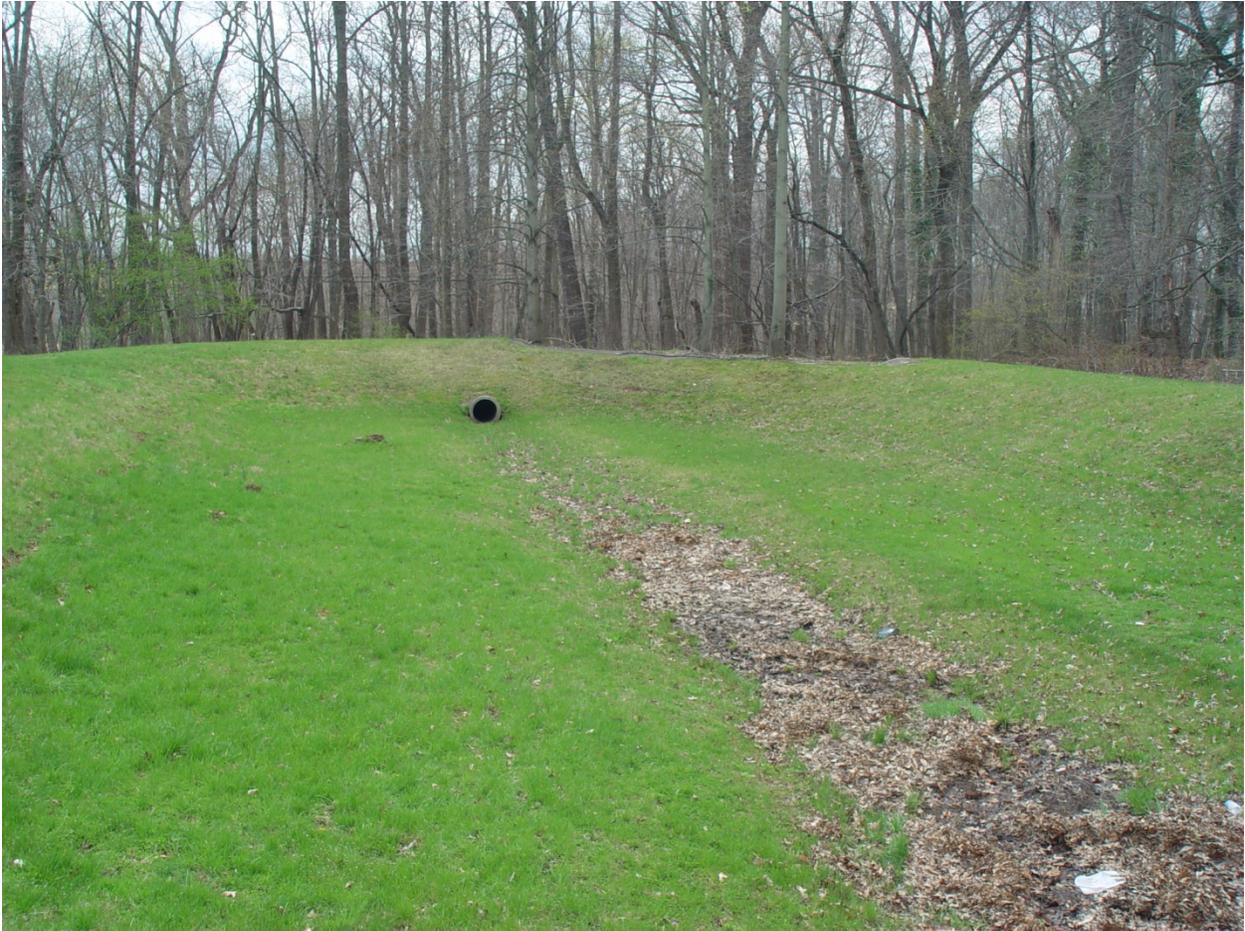
**Prior Condition - Valentine Estates Basin.**

The outlet pipe is at the top of the picture. The emergency spillway is located just to the right of the outlet pipe and is obstructed with trees.

3. The emergency spillway was too narrow and it had become obstructed with mature trees. In the event of a large rainfall event (exceeding the 100-year storm event), the spillway would not function as designed and property damage could occur. **The project removed the tree obstructions and widened the emergency spillway. The new emergency spillway allows for higher discharge rates at lower velocities resulting in less downstream erosion.**

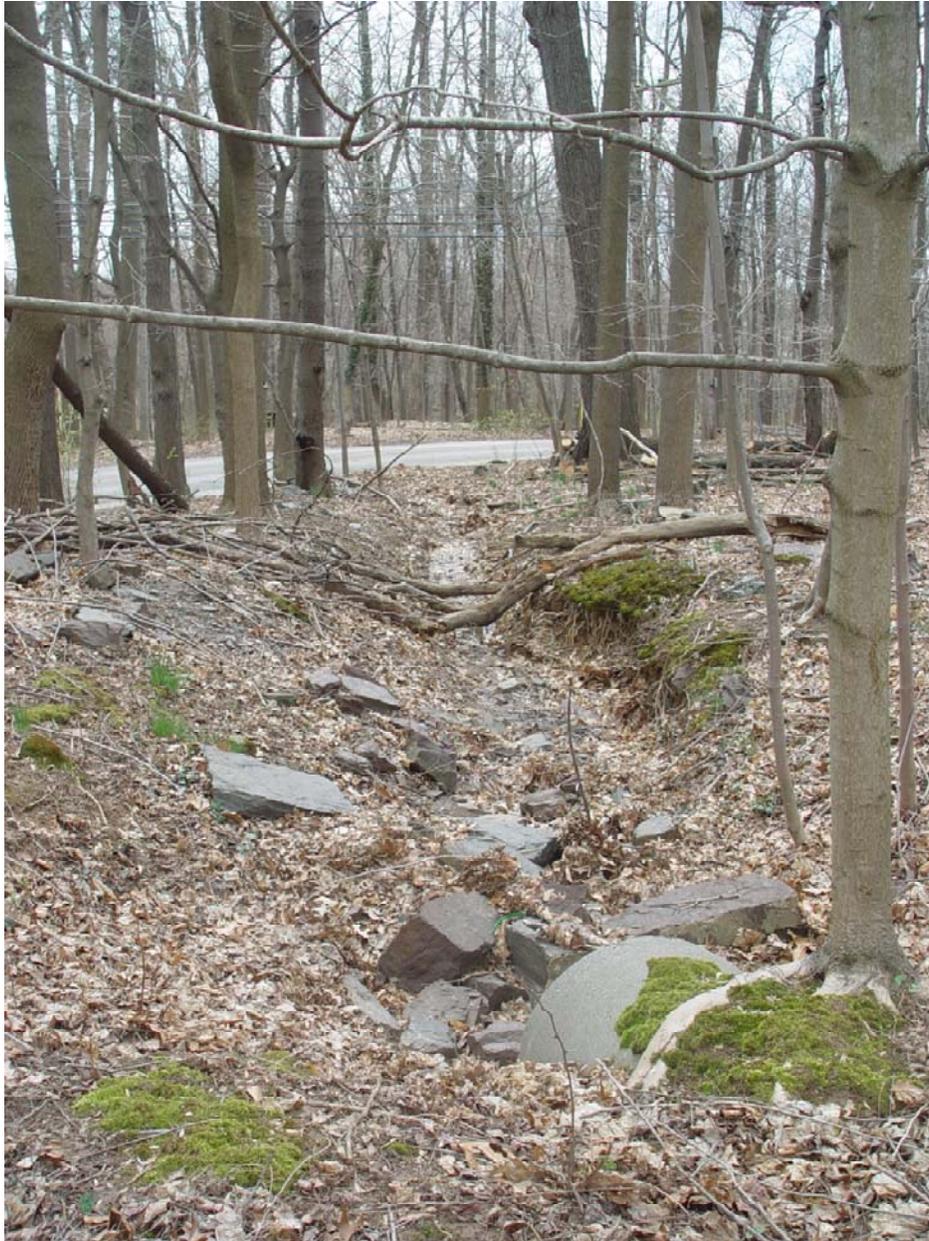
**Prior Condition - Valentine Estates Basin – East View Towards Lewis Lane.**

The outlet pipe from the basin is at the lower right. The basin discharge flows have created substantial channel erosion. In addition, at times the basin discharge flows surcharge across Lewis Lane.

1. Severe erosion at the outlet to the basin and along Lewis Lane due to the lack of outlet control. The lack of outlet control resulted in frequent washouts along Lewis Lane which is immediately downstream of the basin outlet. **The project included re-grading of the outlet channel, installation of a new outlet control structure and the installation of rip-rap to dissipate the energy of the discharge flows.**

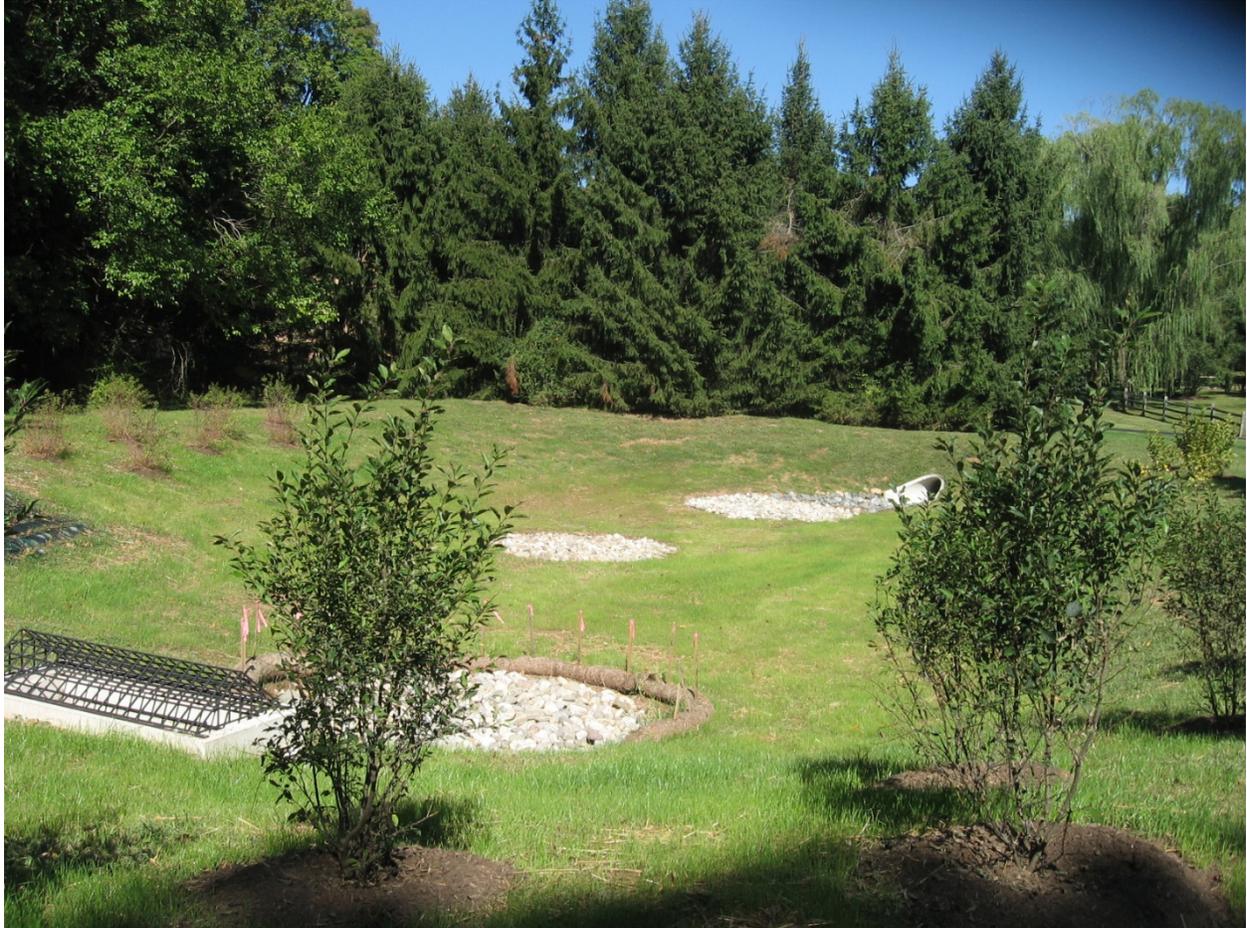
**Project Completion - Valentine Estates Basin.**

The new outlet structure is on the left side of the picture and the inlet pipe can be seen on the top right side of the picture. The three new infiltration pits are located where the rock is visible.

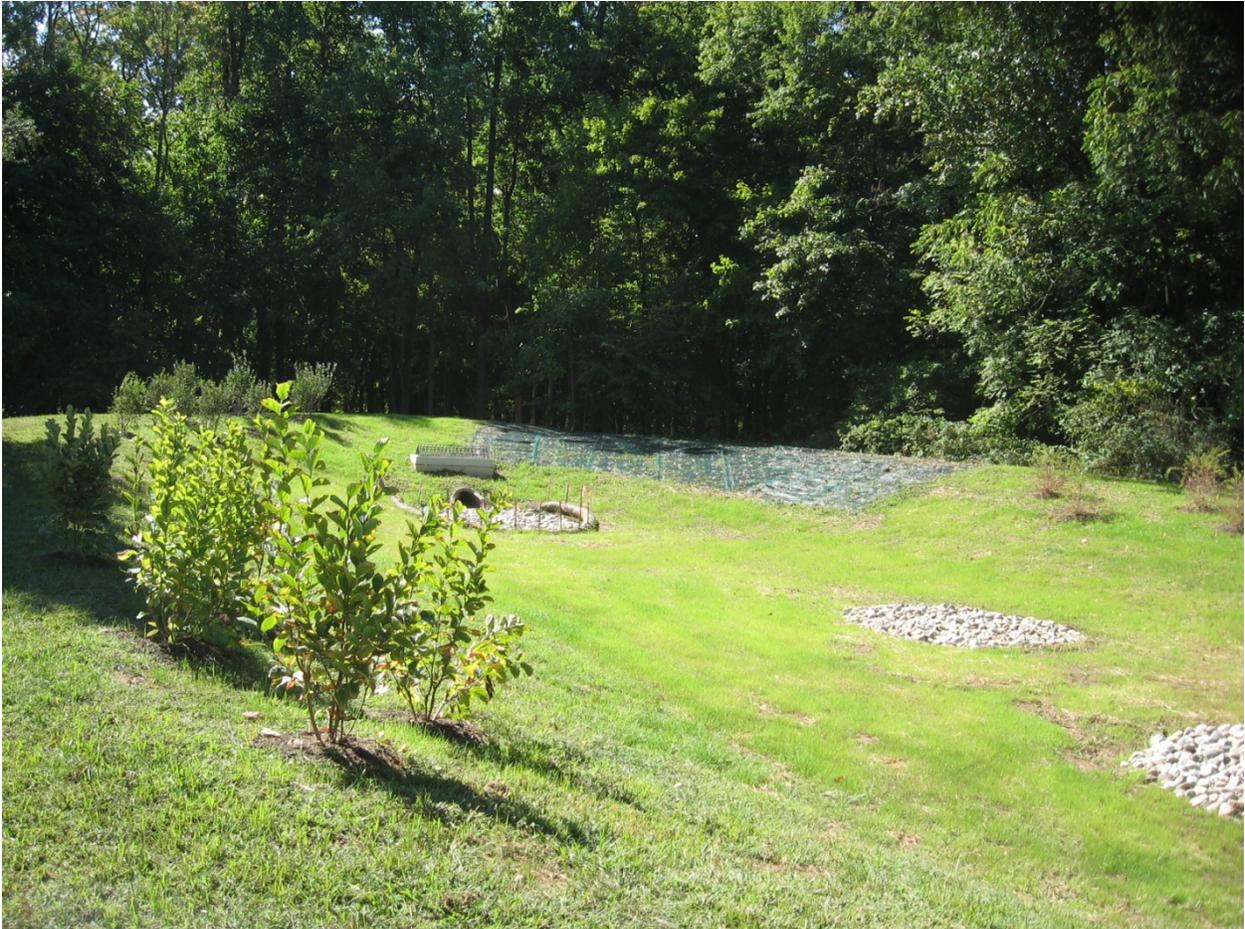
**Project Completion - Valentine Estates Basin.**

The new outlet structure is located in the center of the picture. The new emergency spillway is located where the green matting is visible to the right of the outlet structure.

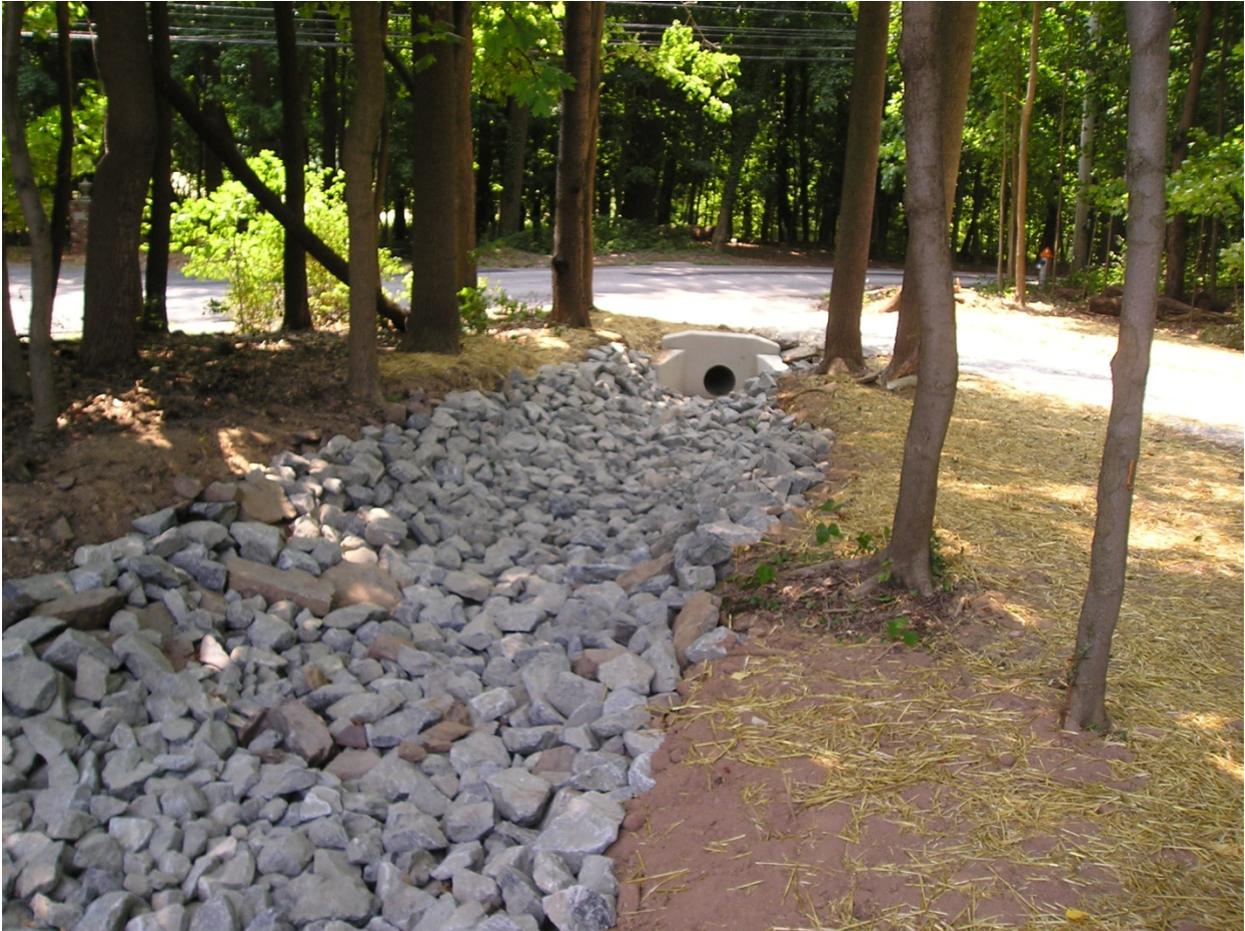
**Project Completion - Valentine Estates Basin – East View Towards Lewis Lane.**

The channel leading from the basin outlet has been re-graded and lined with rip-rap to minimize erosion.
