APPENDIX C

TMDL Strategy – Stream Restoration and Stabilization

**Stream Restoration and Stabilization at Rose Valley Creek and
Wissahickon Creek as part of the BoRIT Superfund site (2008 – 2015)**

Wissahickon Creek Streambank Restoration and Stabilization

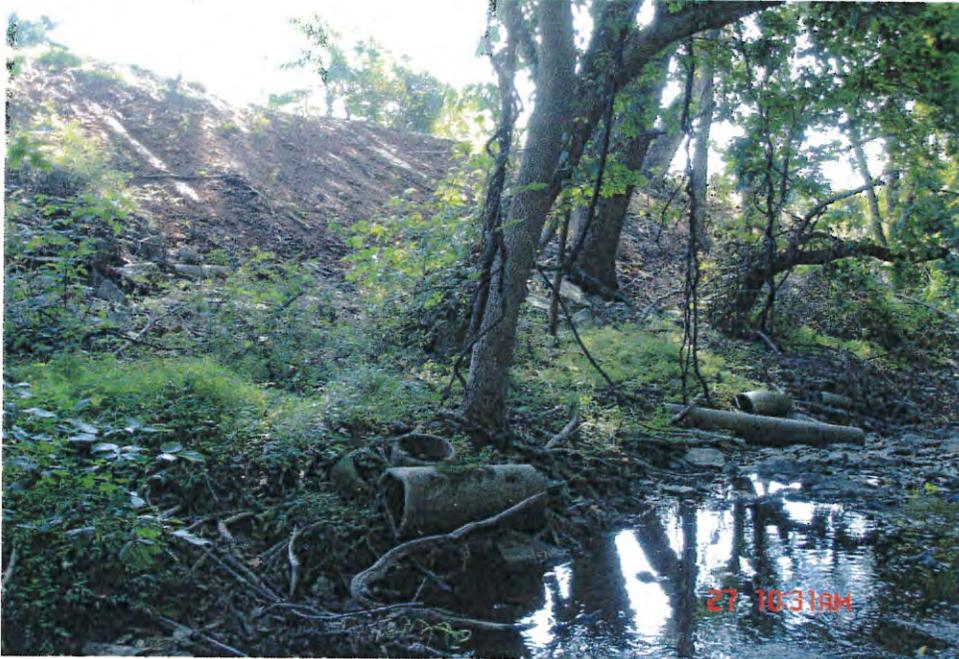
The picture above shows asbestos-containing material (ACM) along the WC bank adjacent to the park property. All the big pieces were picked up and put in roll-offs, which were sent out for proper off-site disposal.

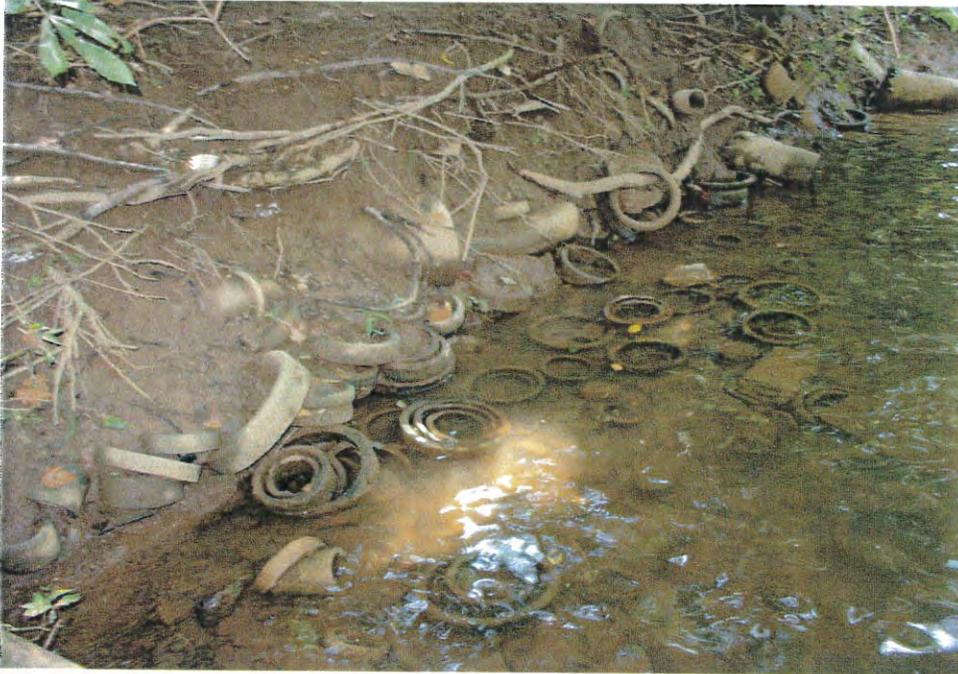
Same as the picture above.

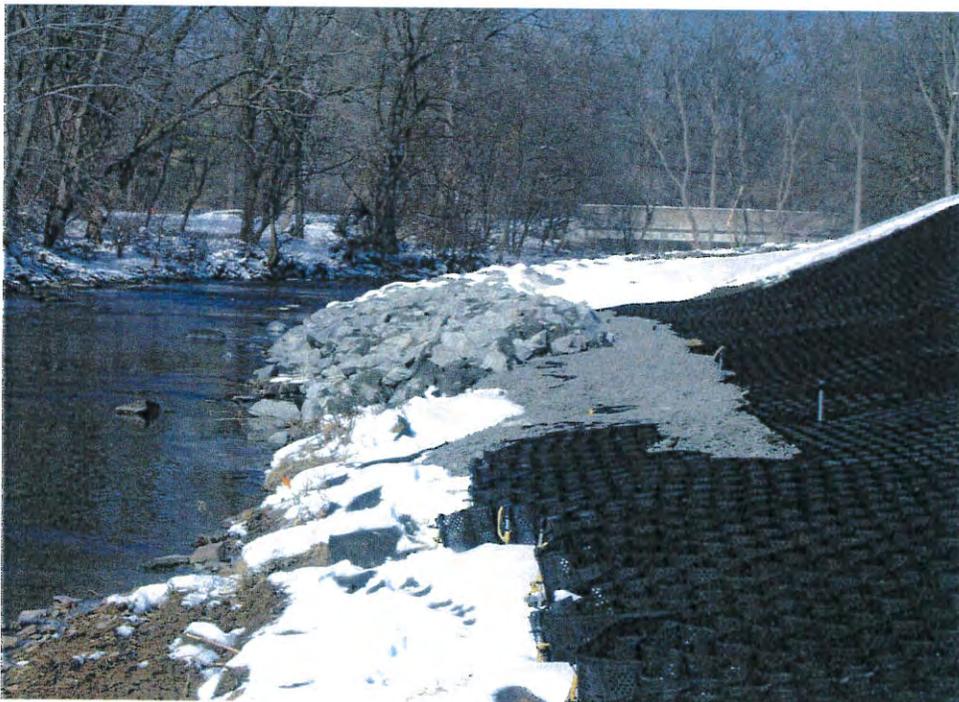
This picture shows the geocells on the slope and how the first few feet from the water's edge were filled with stone and then riprap (boulders) over the area to protect that section from strong flow during heavy rain events.

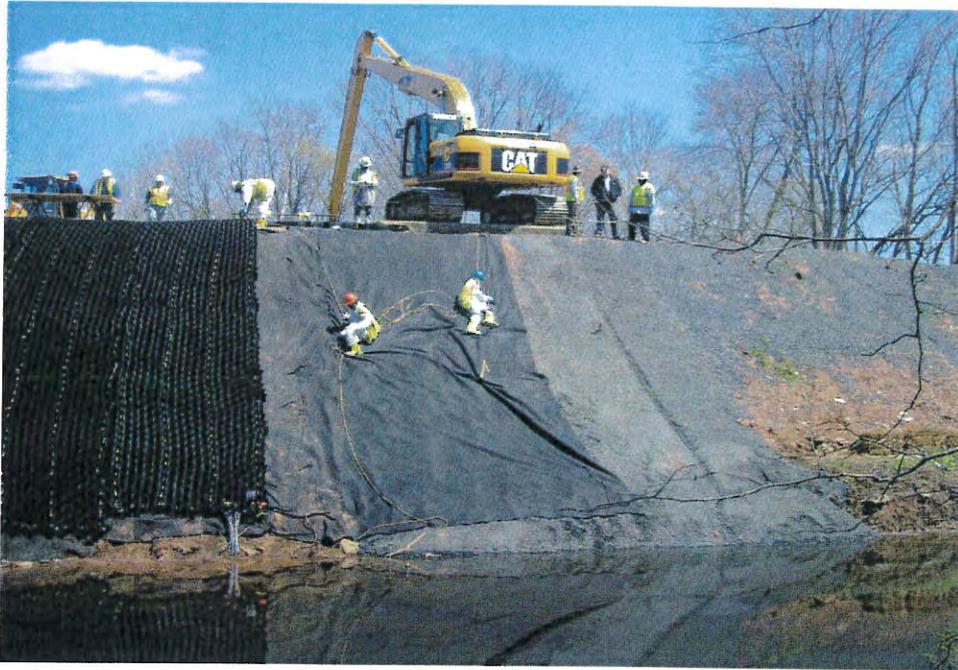
This picture shows the layer of geotextile fabric (where the guys are) used to cover the slope prior to installing the geocells.

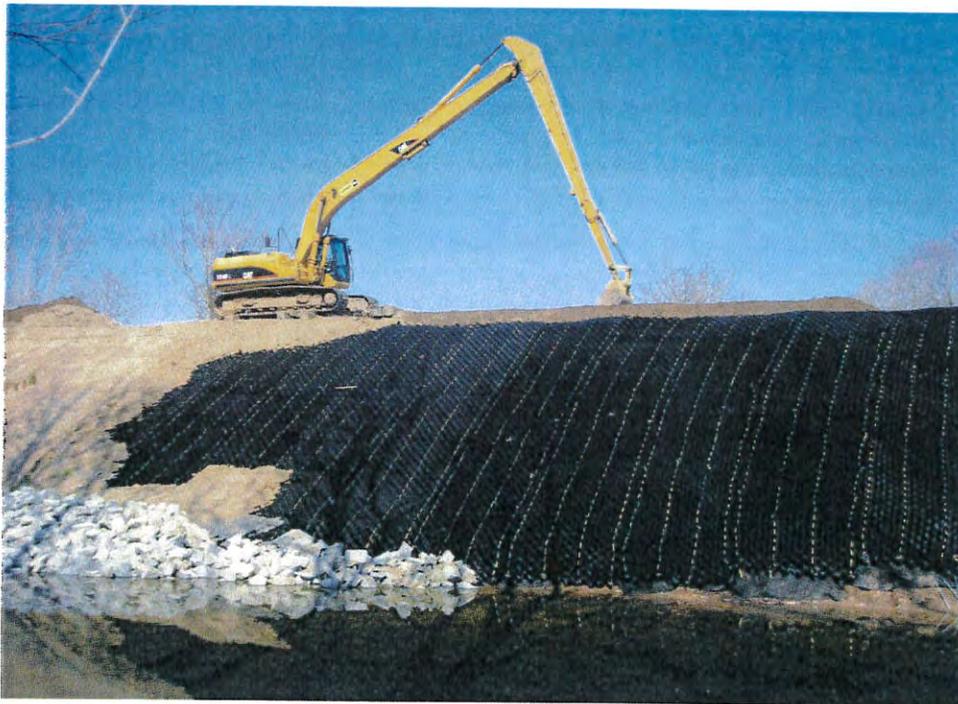
This picture shows how the geocells were filled with topsoil. It also shows the tendons (yellow strings) which were used to anchor the geocells at the top of the slope.

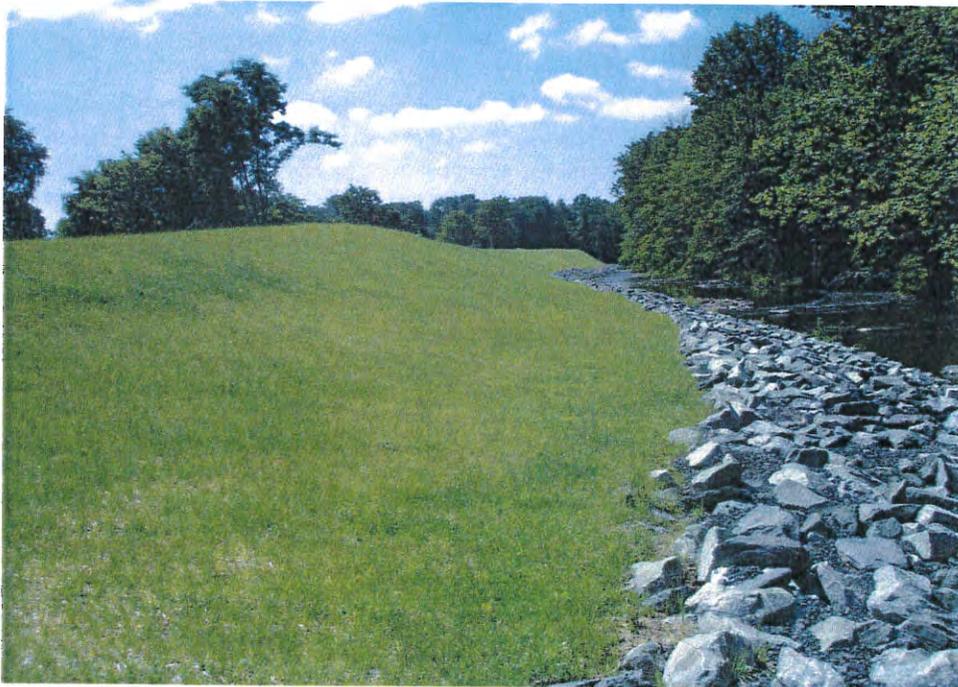
This picture shows how well the vegetation took.

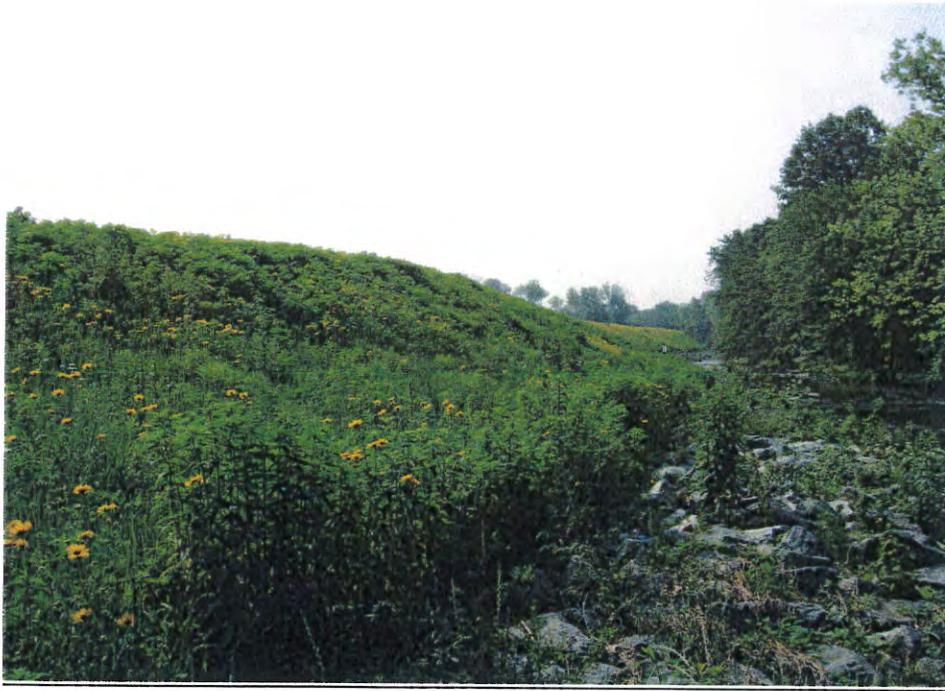
Same as above.

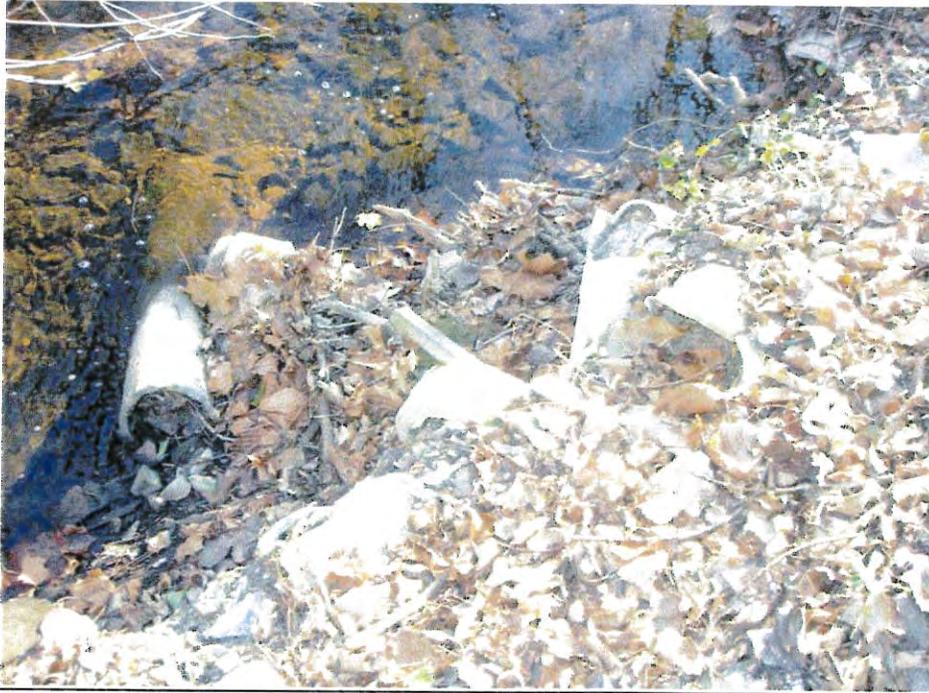
The picture above shows asbestos-containing material (ACM) in Rose Valley Creek. All the big pieces were picked up and put in roll-offs, which were sent out for proper off-site disposal.

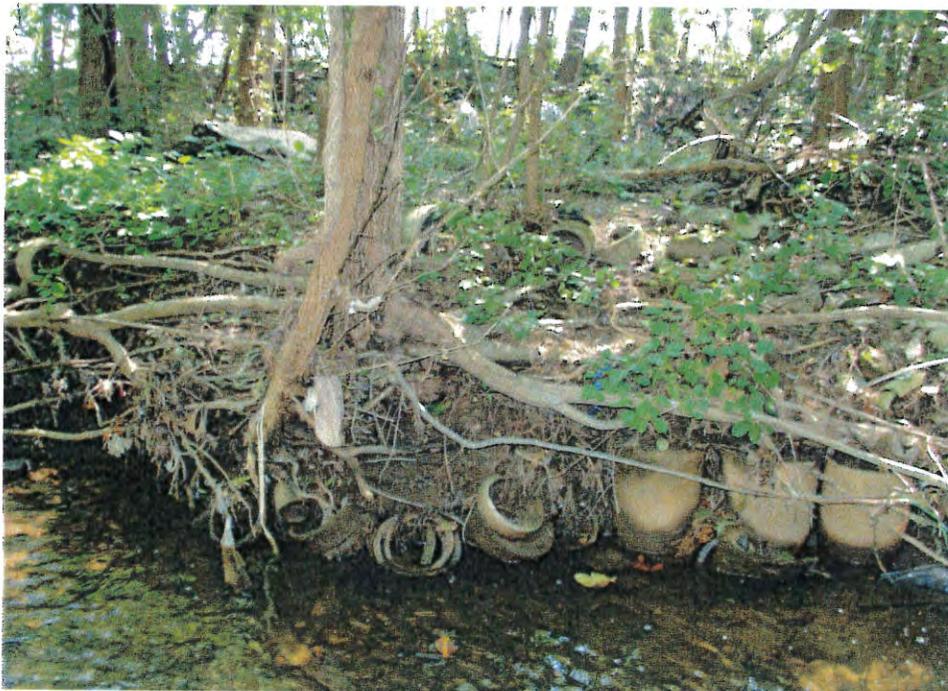
Same as above.

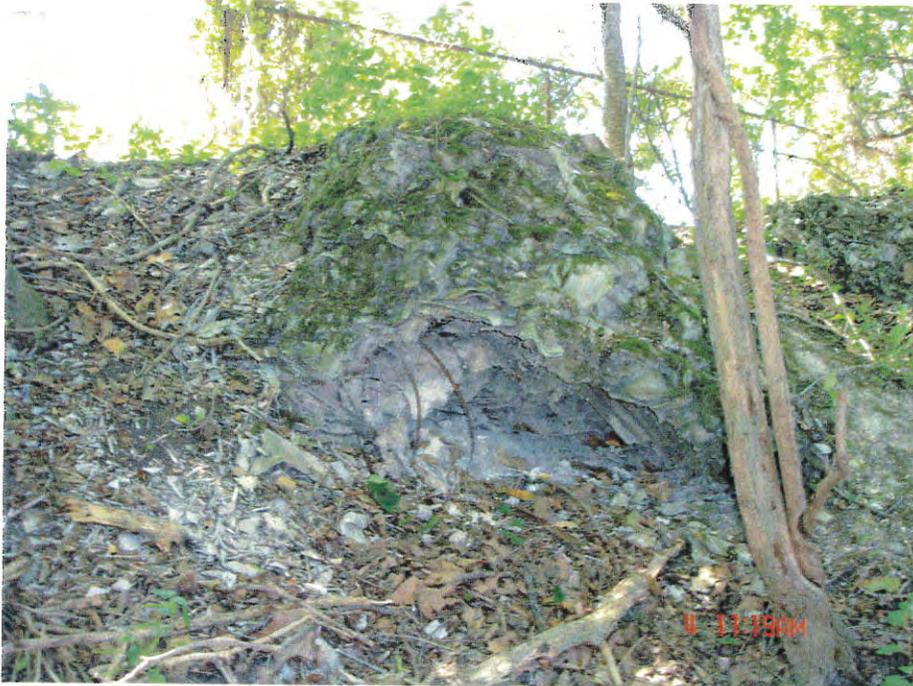
The picture above shows asbestos-containing material (ACM) along the slope by Rose Valley Creek. All the big pieces were picked up and put in roll-offs, which were sent out for proper off-site disposal.

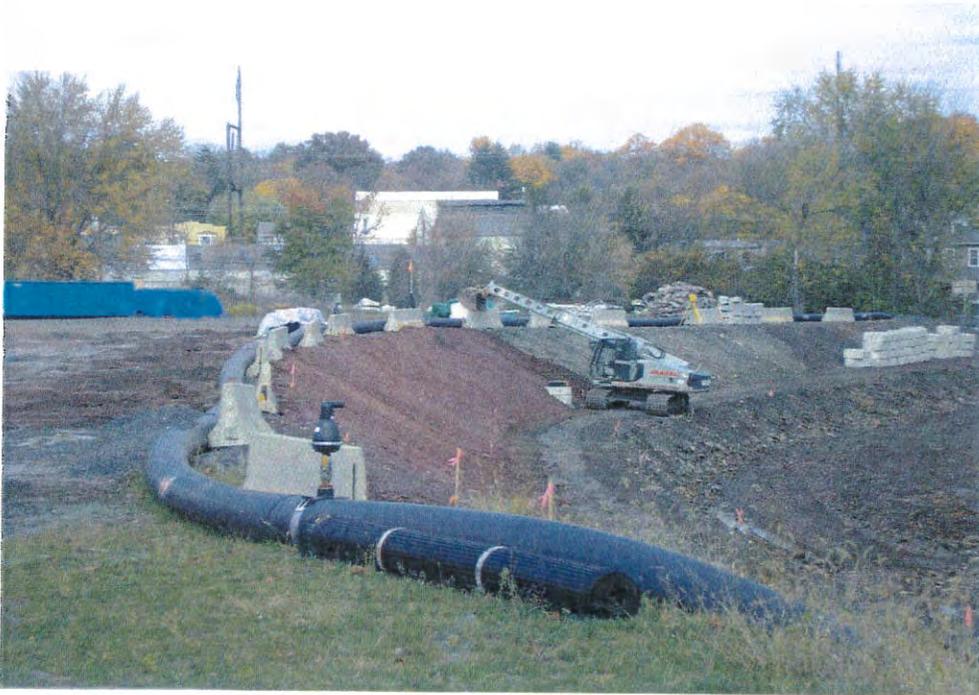
To be able to “work dry,” we bypassed Rose Valley Creek through the pipe shown above.

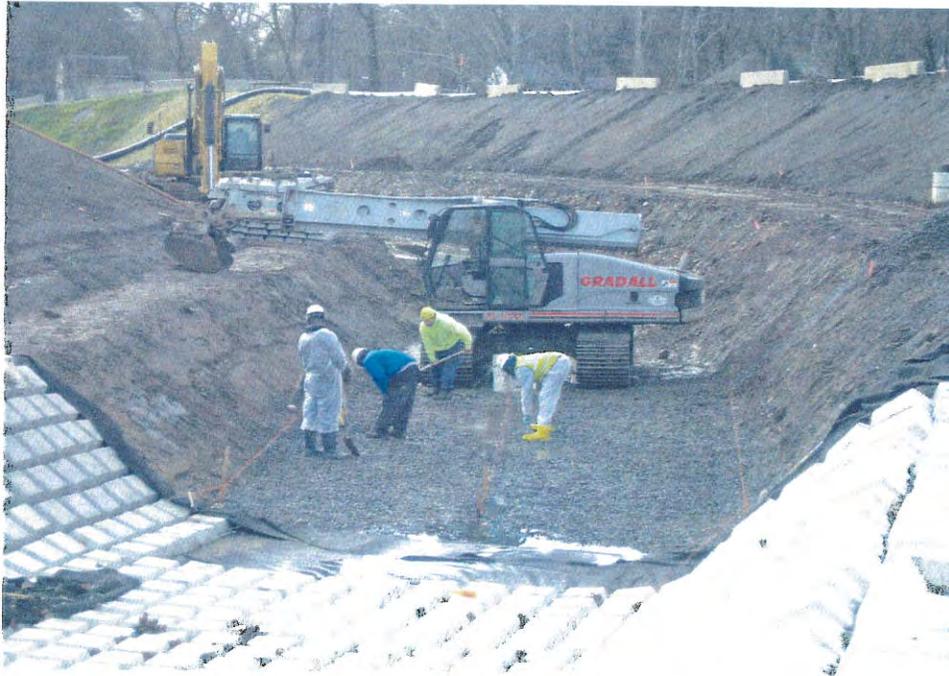
This picture shows how the channel was widened, the floor was leveled with stone, the geotextile fabric was installed and then the cable concrete mats (CCMs) were installed from one side, across and then over to the other side.

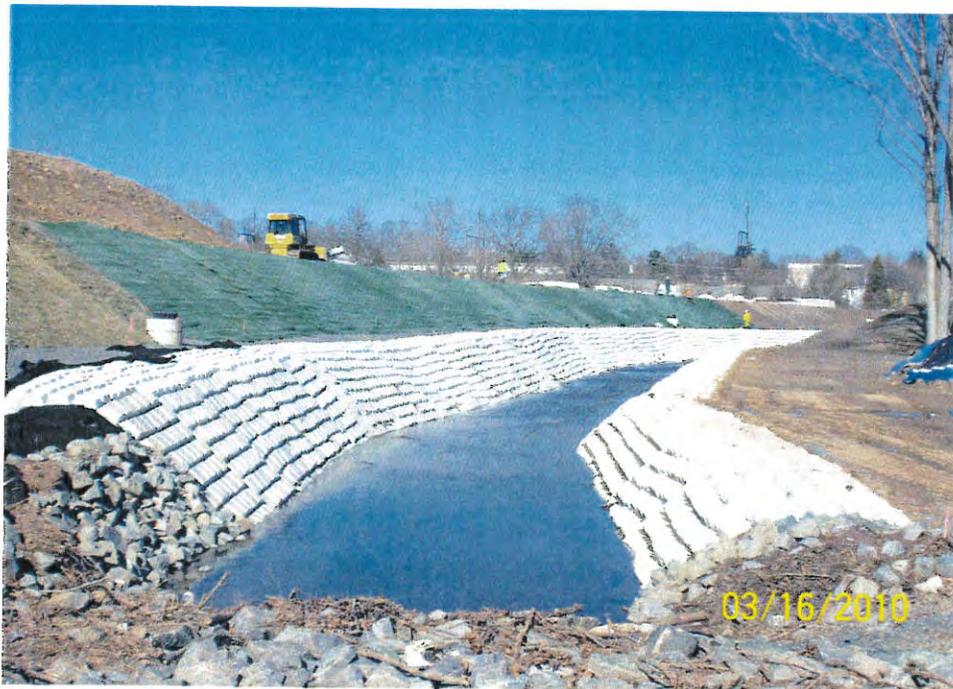
This picture shows the CCMs and the heavy erosion mat that was used on the “upper slope,” adjacent to the Park property.

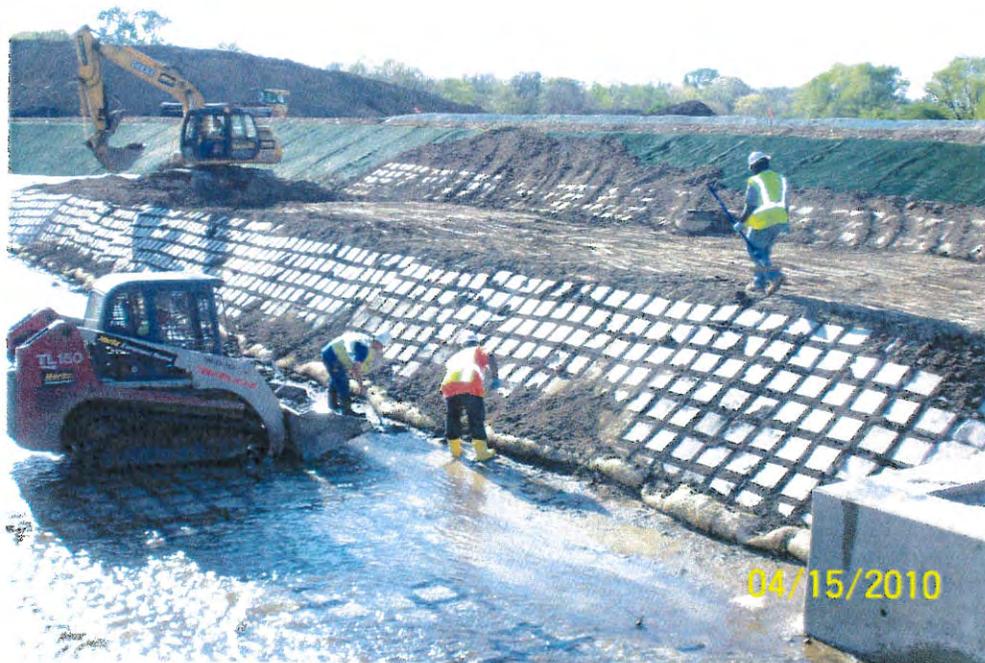
The gaps of the CCMs were filled with topsoil, as well as the erosion mat on the “upper slope.” Both areas were then hydro-seeded to promote vegetation.

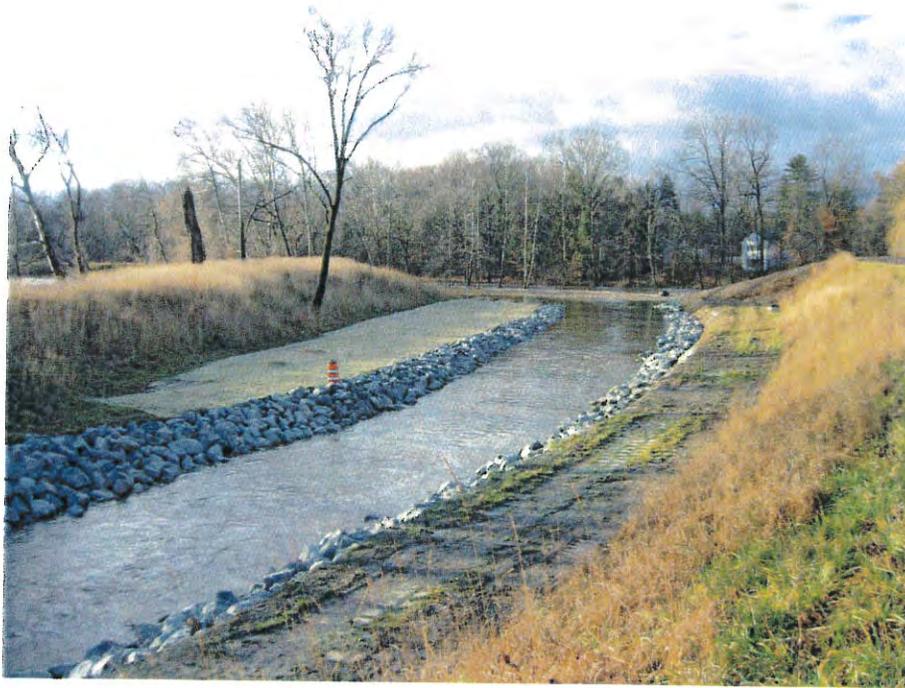
Riprap was added along the toe of the stream banks to help keep everything in place, especially during big storm events.

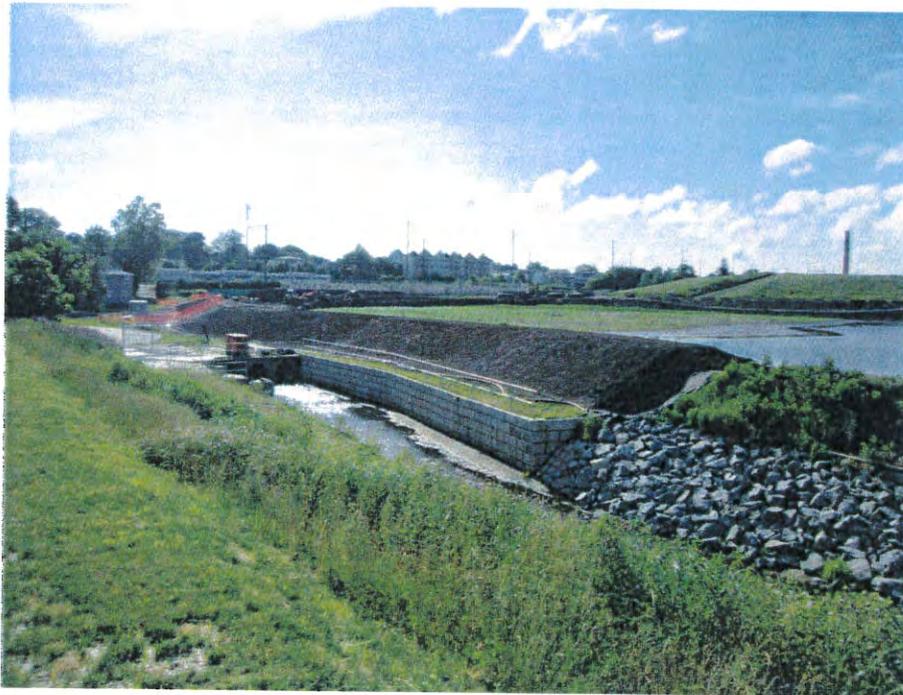
This picture shows the outside section of the pond's berm closest to Rose Valley Creek ready for hydro-seeding and the erosion mats.
